**INITIAL INVESTIGATION OF
SUBSURFACE PETROLEUM
CONTAMINATION REPORT**

**HEALD'S GARAGE
4 BEAMAN STREET
POULTNEY, VERMONT 05764**

(VT DEC SITE #96-2120)
GI #2974980

May 1997

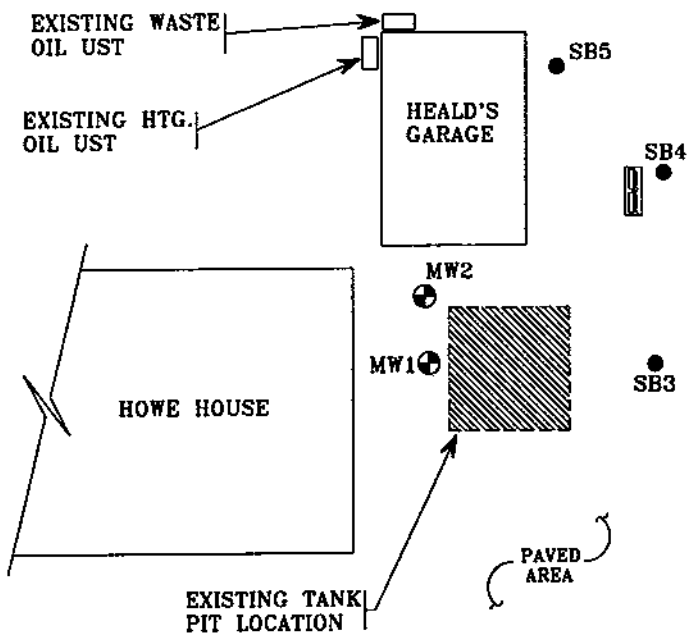
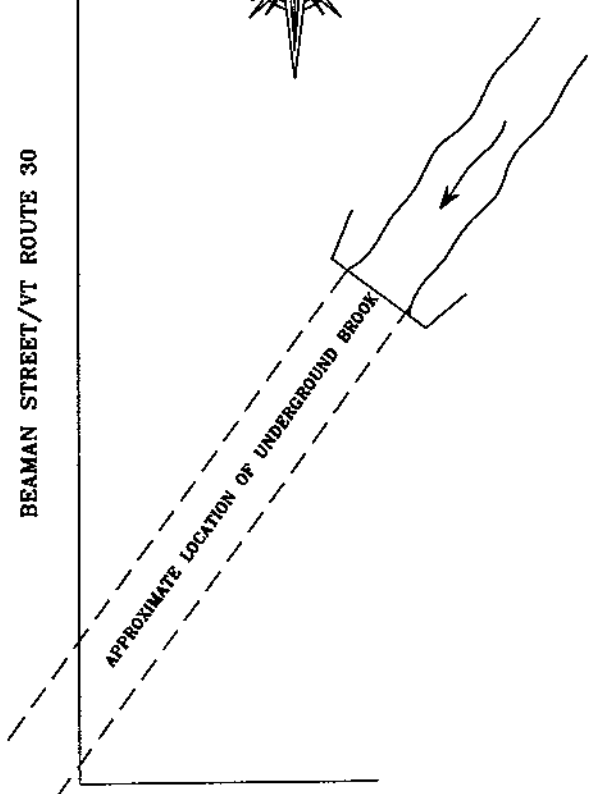
HEALD'S GARAGE			
POULTNEY,		VERMONT	
SITE MAP			
DATE: 3/27/97	DWG.#:2	SCALE: 1"=40'	DRN.:SB APP.:CW

Three soil borings (SB-3, SB-4, and SB-5) were drilled on March 24, 1997, by Adams Engineering, under the direct supervision of a Griffin hydrogeologist. The soil borings were advanced with a truck mounted vibratory soil core sampler. No monitoring wells were installed in the borings because refusal was encountered at shallow depths with no evidence of groundwater. The soil boring locations are indicated on the Site Map (Appendix A).

Soil boring SB-3 was located approximately 30 feet south of the fuel dispenser island and east of the USTs. Soil boring SB-4 was located directly east of the fuel dispenser island, close to the source area. Soil boring SB-5 was located near the service station, approximately 25 feet northwest of the fuel dispenser island.
